Section 4(f) De Minimis Determination

PROJECT DESCRIPTION

City of Encinitas Highway 101 Repair and Restoration Project - 4(f) de Minimis Memo

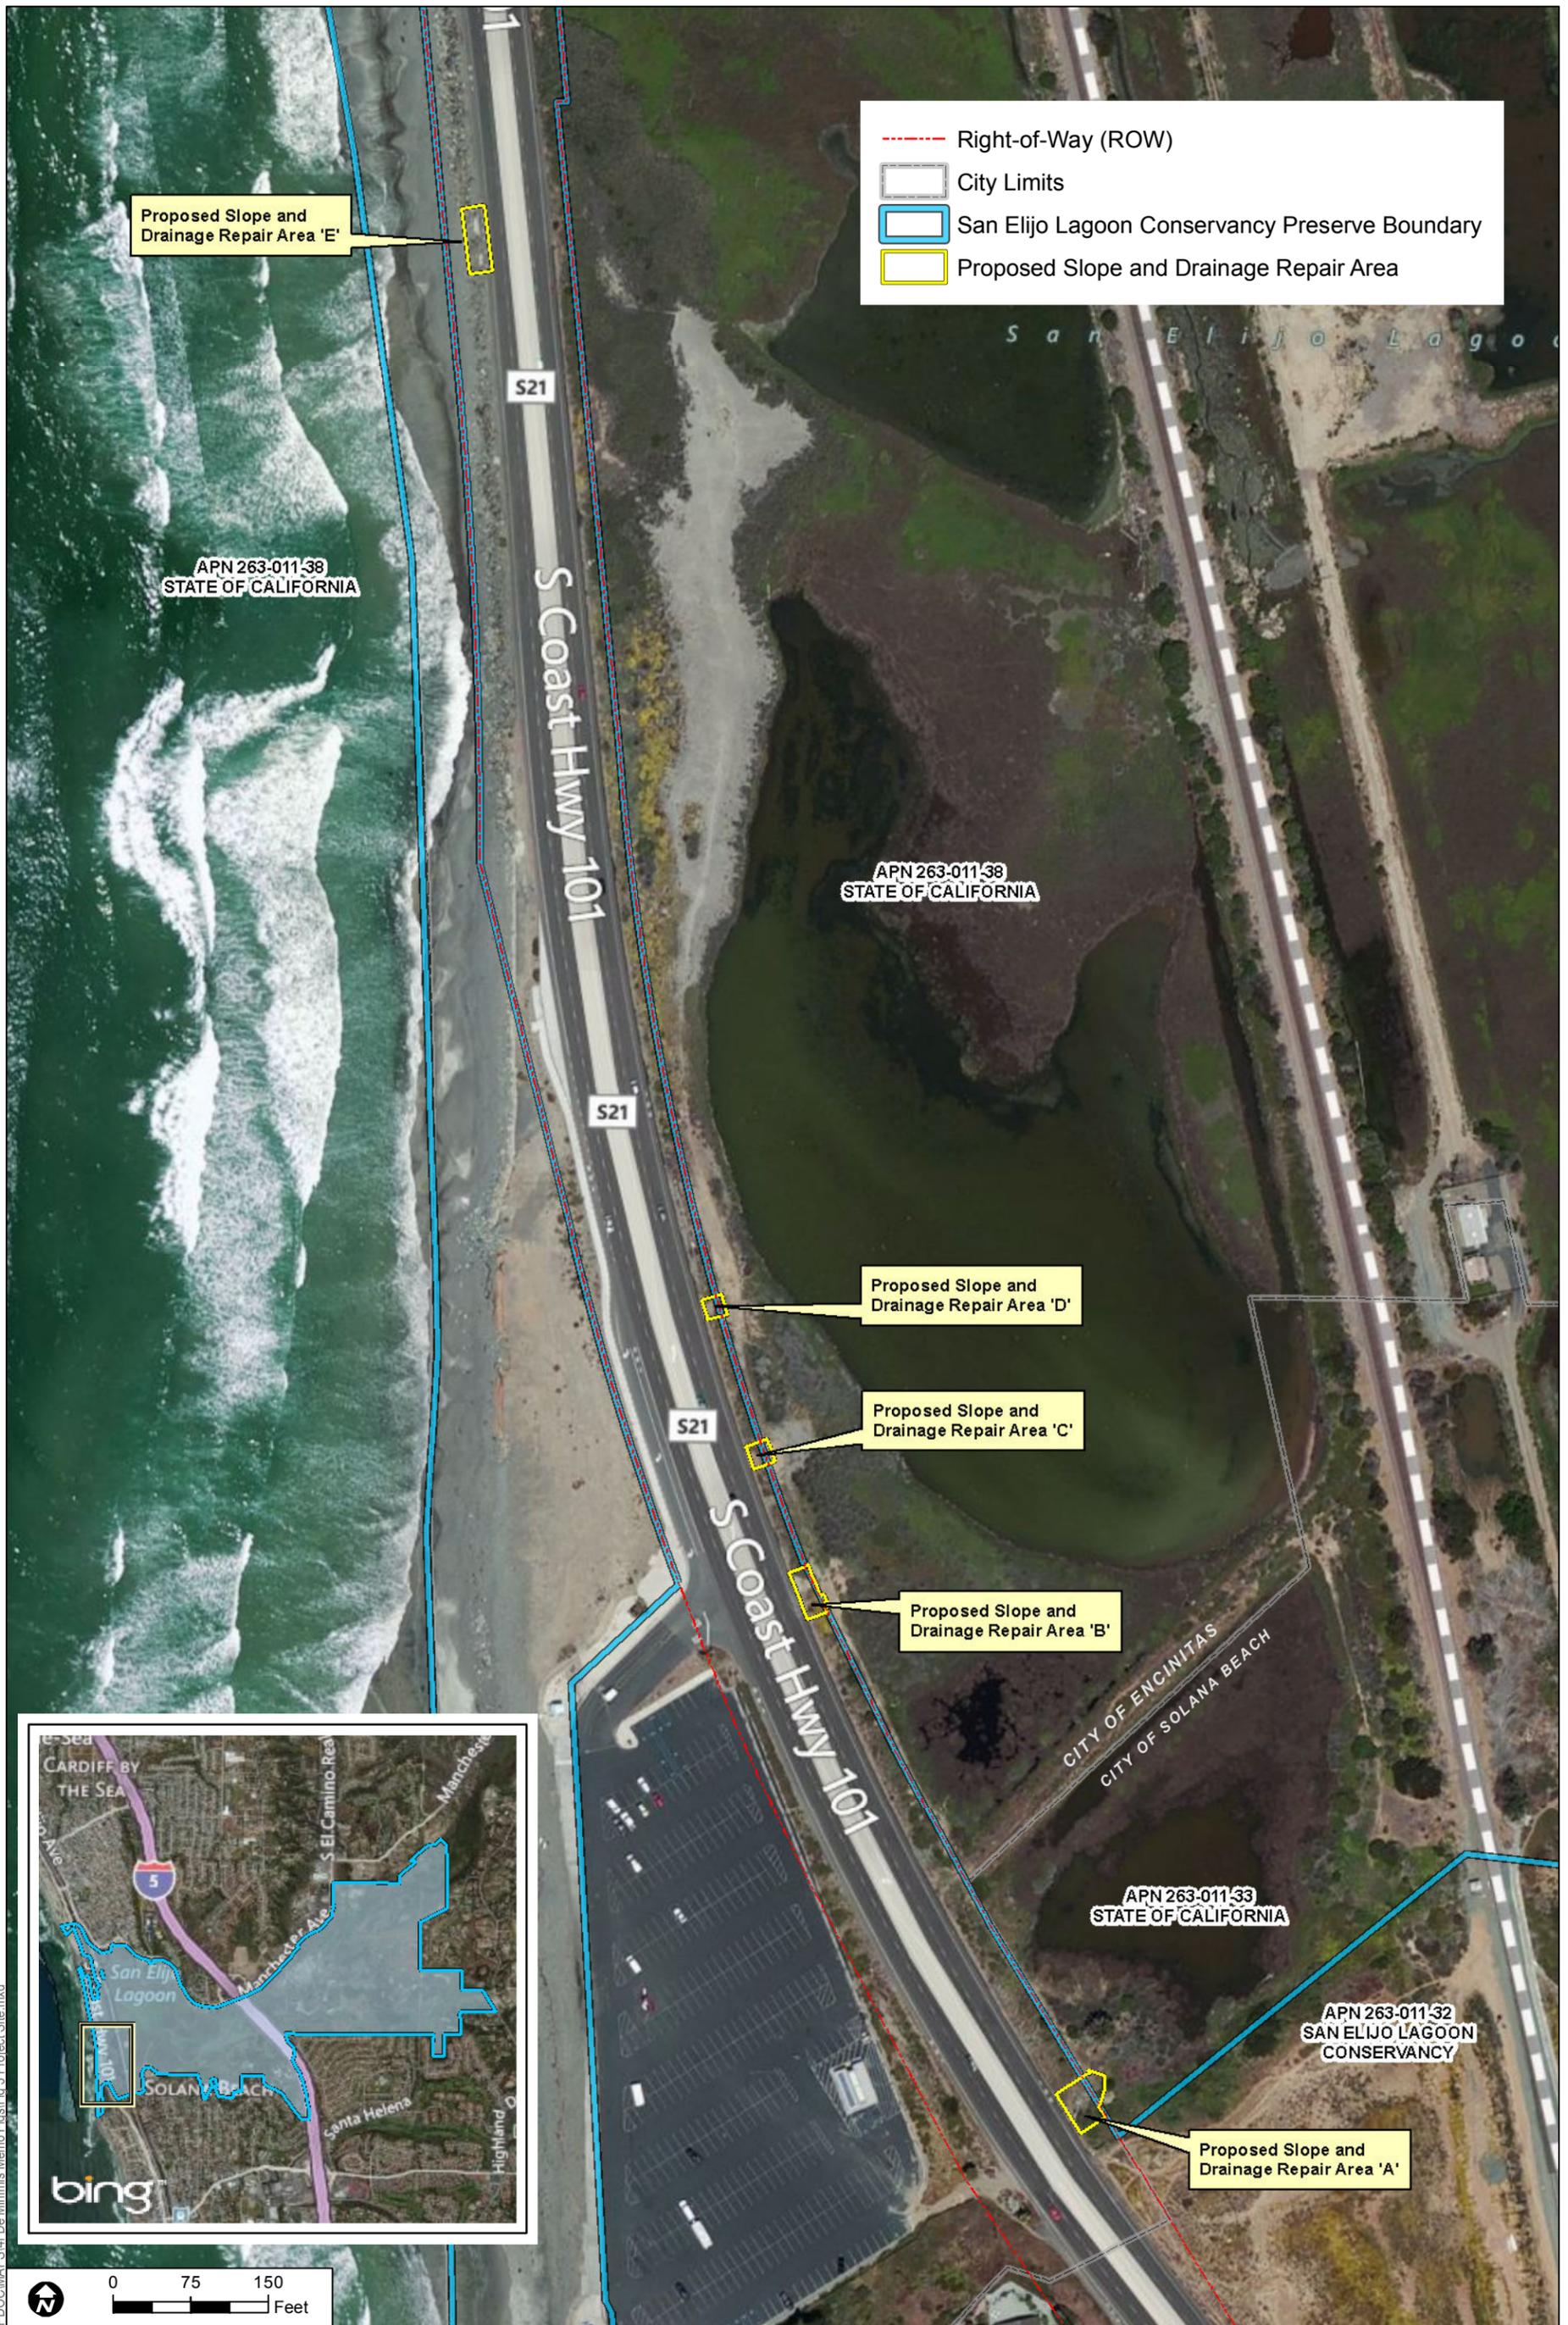
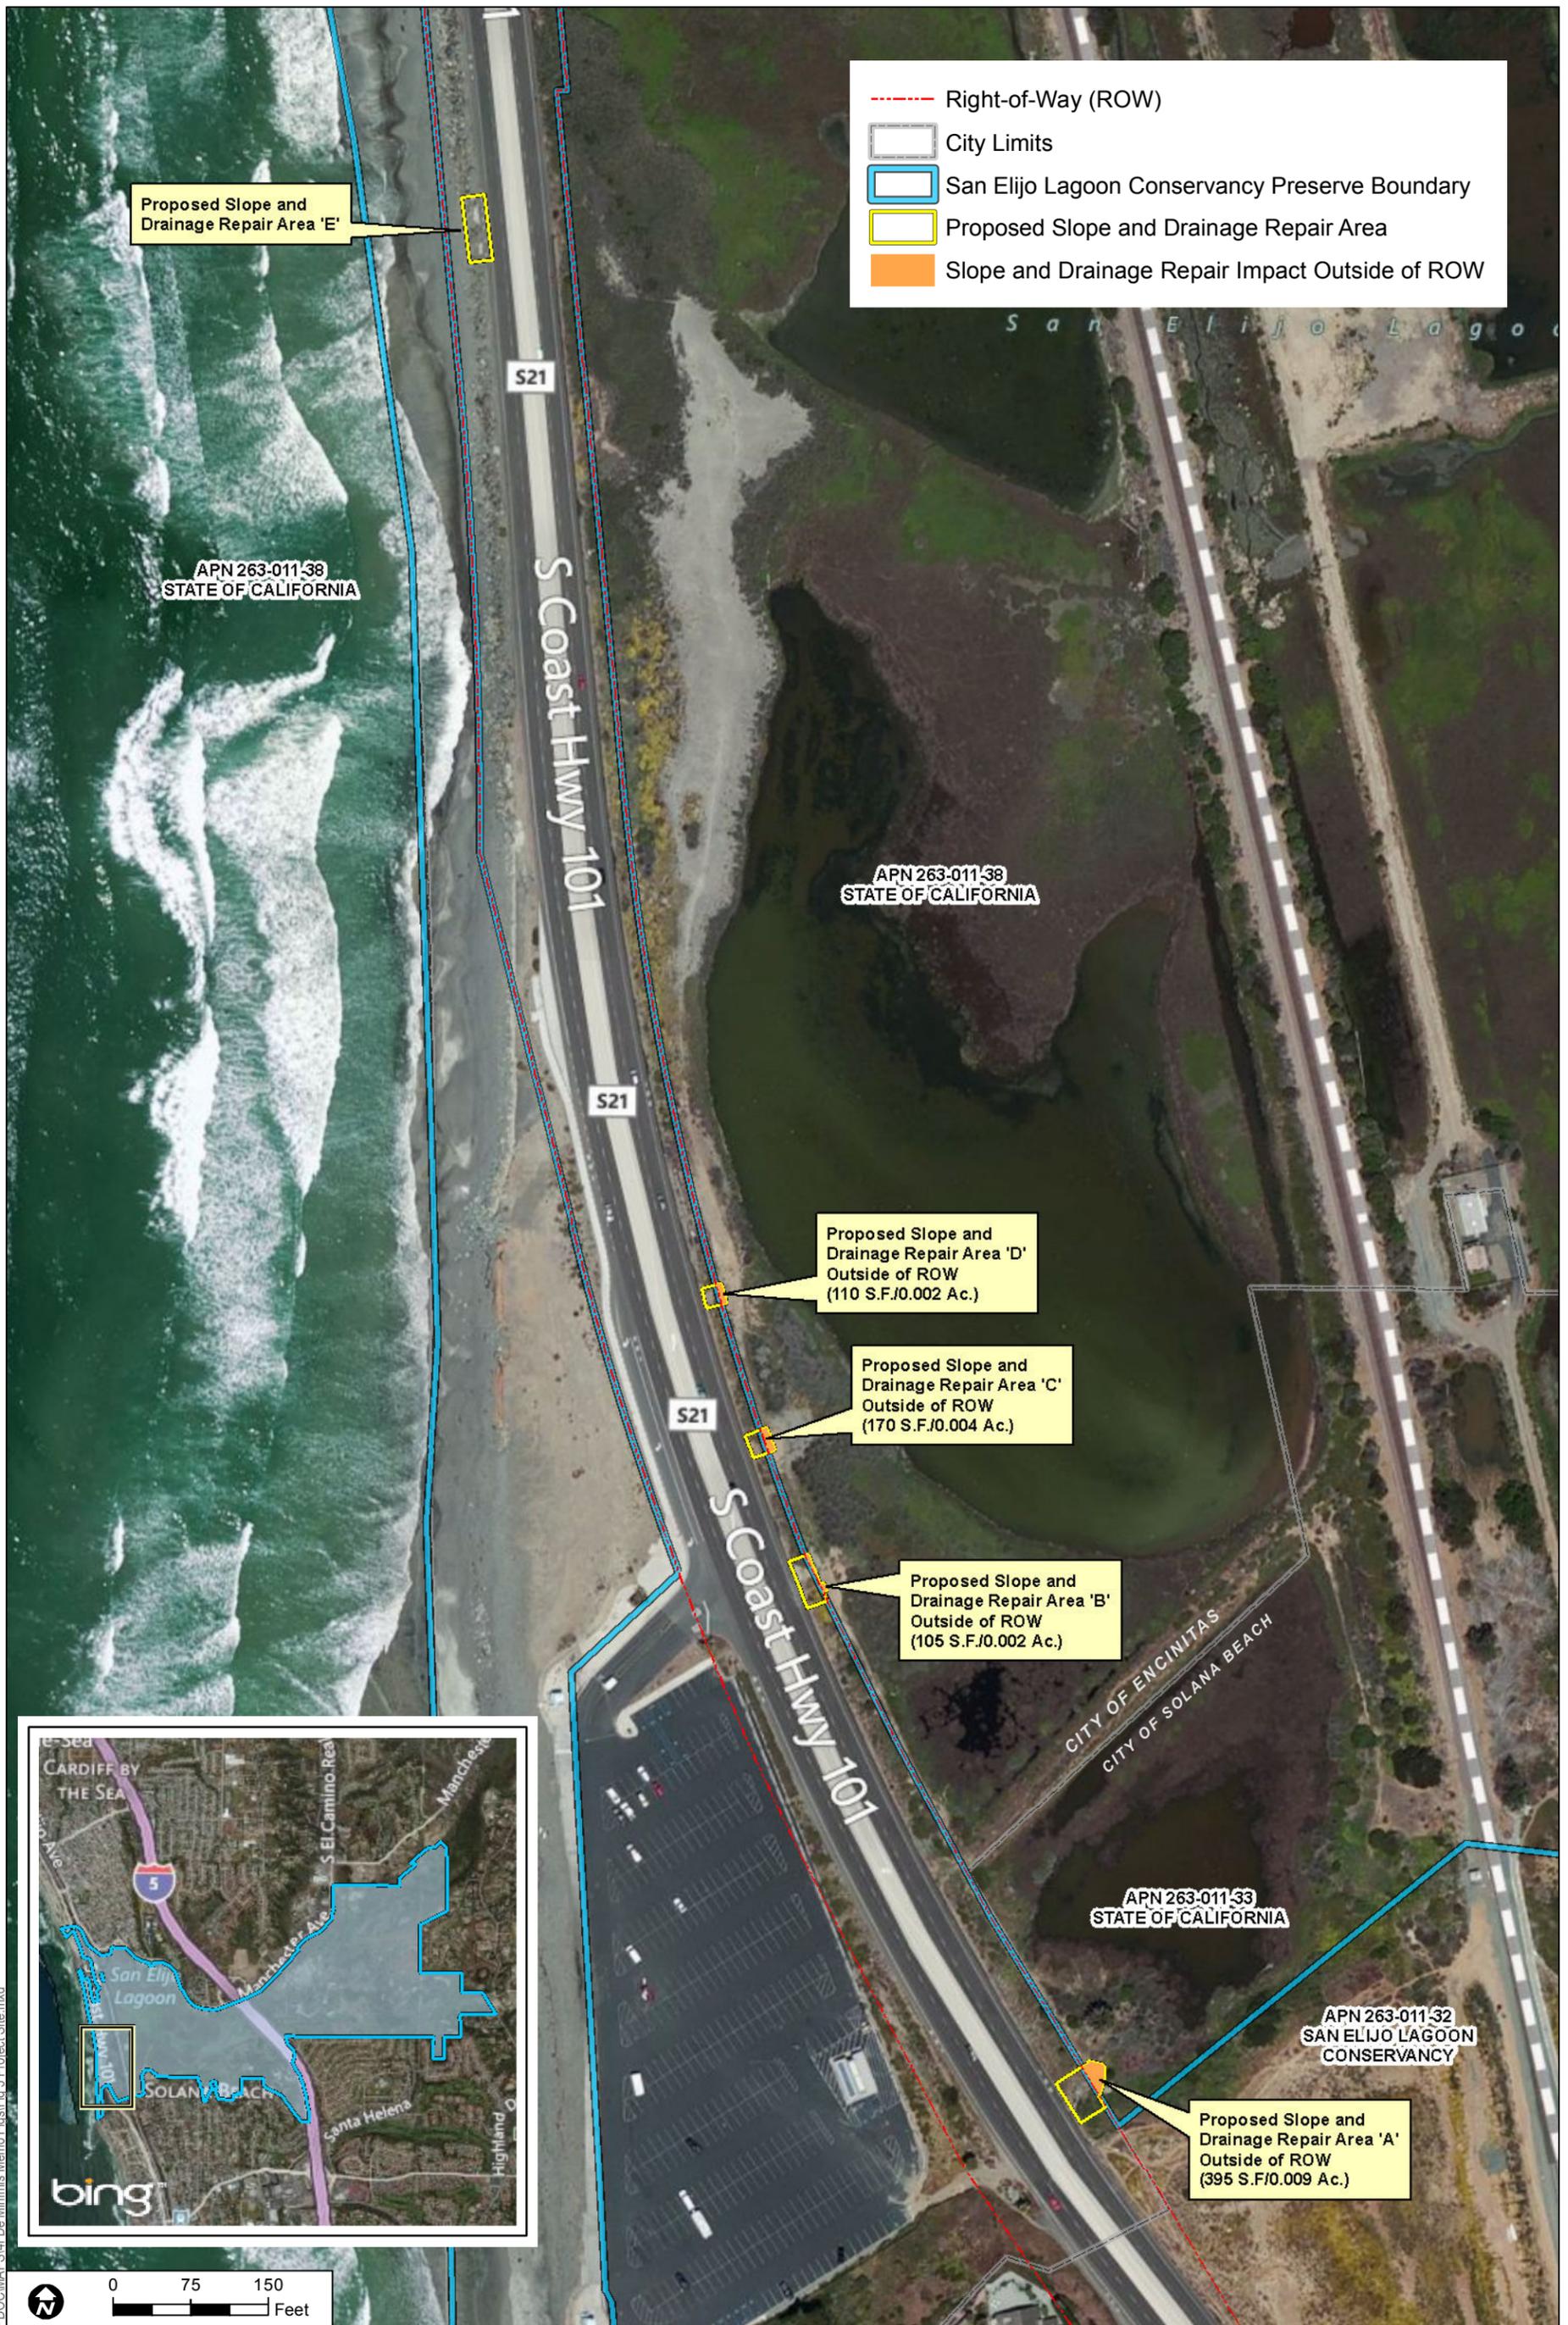
FIGURE 4

Proposed Slope and Road Repair Project Site Outside of Right-of-Way

location will extend in to the San Elijo Lagoon Ecological Reserve, a Section 4(f) resource. (See Figure 4, Work Impacts Outside City Right-of-Way).

As shown on Figure 4, the project would require roadway work within the Reserve. In total, the project would use a total of 0.014-acres along the southwest portion of the lagoon and adjacent to Highway 101 (approximately 0.009-acres at Area A; approximately 0.001-acres at Area B; approximately 0.002 -acres at Area C; and approximately 0.003 -acres at Area D). The project would use less than 0.002% of the total Reserve (see Figure 3). With respect to the functions and values of the Reserve at locations A-C, in these areas the Reserve is somewhat diminished through the evidence of disturbed habitat due to the proximity of these locations to the adjacent road slopes and drainage facilities.

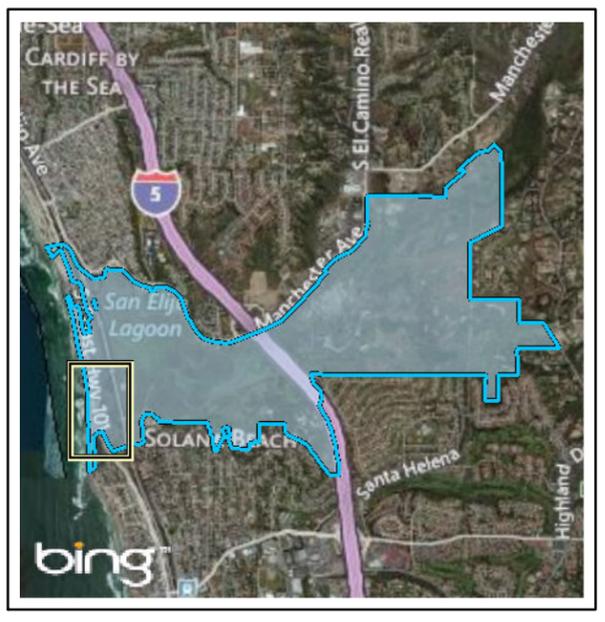
FIGURE 5A
Mitigation/Revegetation Treatments Map

REVEGETATION	ACRES
Coastal Sage Scrub Enhancement Area	0.12
Coastal Sage Scrub Establishment Area	0.15
Coastal Sage Scrub Restoration Area	0.01
Coastal Strand Enhancement Area	0.34
Coastal Strand Restoration Area	0.09
Middle Coastal Salt Marsh Enhancement Area	0.09
Middle Coastal Salt Marsh Establishment Area	0.03
Middle Coastal Salt Marsh Restoration Area	0.01
Open Channel Establishment Area	0.01
Open Channel Restoration Area	0.01
Sensitive Plant Restoration Area	0.05
TOTAL	0.91

In addition, the proposed project also incorporates non-road way associated restoration work within the San Elijo Lagoon Ecological Reserve meant to enhance this resource's role as an ecological reserve (See Figures 5A and 5B, Mitigation/Revegetation Treatment Maps). During the 2010 Emergency roadway opening project referenced above, coastal dune and coastal salt marsh portions of the Reserve were disturbed by earth moving equipment and soil removed from the Reserve was used to shore up eroding portions of Highway 101. These previously disturbed areas would be restored to their existing grades and prepped for planting/seeding. All work in these areas would be done using hand labor only. The project would remove non-native/exotic species and replant the disturbed areas with native species appropriate to the coastal dune and coastal salt marsh habitats.

Specifically, the habitat at Area A is characterized by eroded open channel land cover and middle coastal salt marsh vegetation (Figure 6A, Work Areas Vegetation Impact Map). Following the construction activities, the area will be restored with Diegan Coastal Sage Scrub establishment areas, open channel revegetation area, and middle coastal salt marsh enhancement and restoration (Figure 5A, Mitigation/Revegetation Treatment Map).

At Area B, the habitat primarily consists of middle coastal salt marsh at the toe of the slope and Diegan Coastal Sage Scrub at the top of the slope. (Figure 6B, Work Areas Vegetation Impact Map). These habitats will be restored and enhanced through the project efforts (Figure 5A, Mitigation/Revegetation Treatment Map).

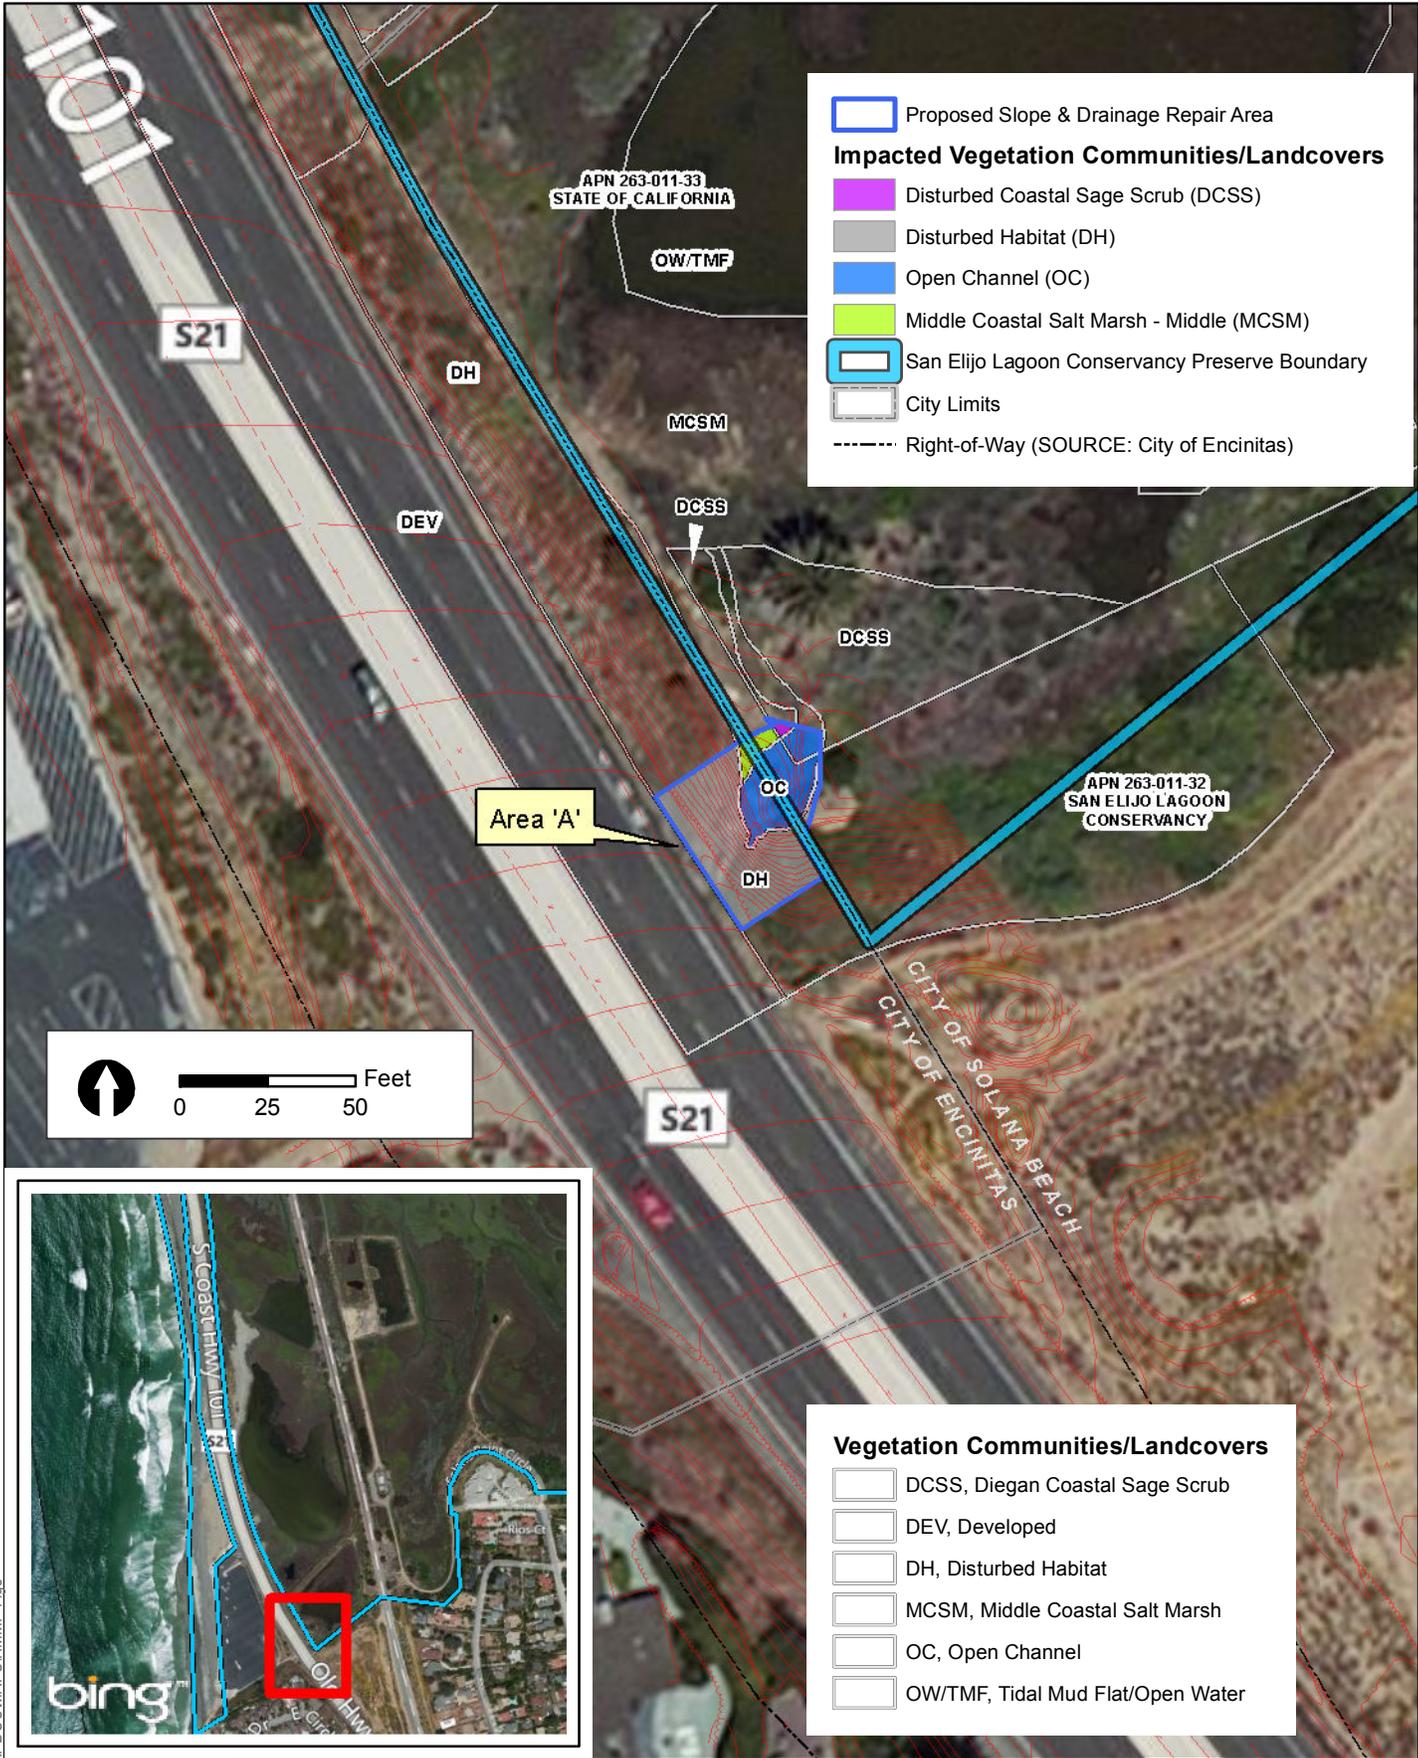
FIGURE 6A

Work Areas Vegetation Impact Map

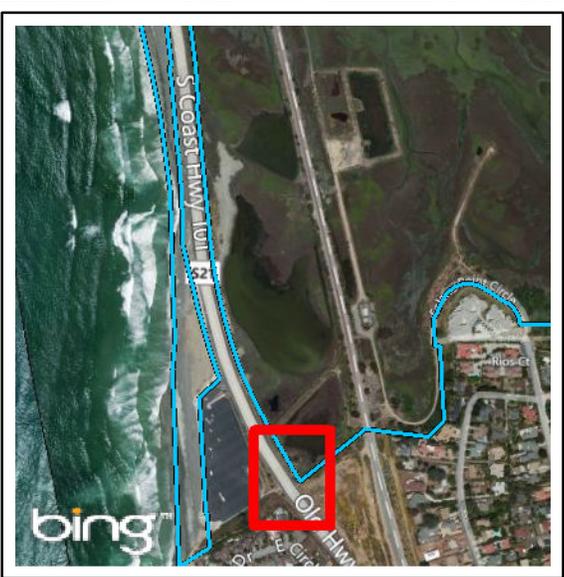
Vegetation Communities/Landcovers
 DCSS, Diegan Coastal Sage Scrub
 DEV, Developed
 DH, Disturbed Habitat
 MCSM, Middle Coastal Salt Marsh
 OC, Open Channel
 OW/TMF, Tidal Mud Flat/Open Water
