Appendix D
Biological Resources Technical Report

Olivenhain Trunk Sewer
Improvements Project
Draft Biological Technical Report

Prepared for:
Infrastructure Engineering Corporation
14271 Danielson Street
Poway, CA 92064
(858) 413-2400

October 7, 2014

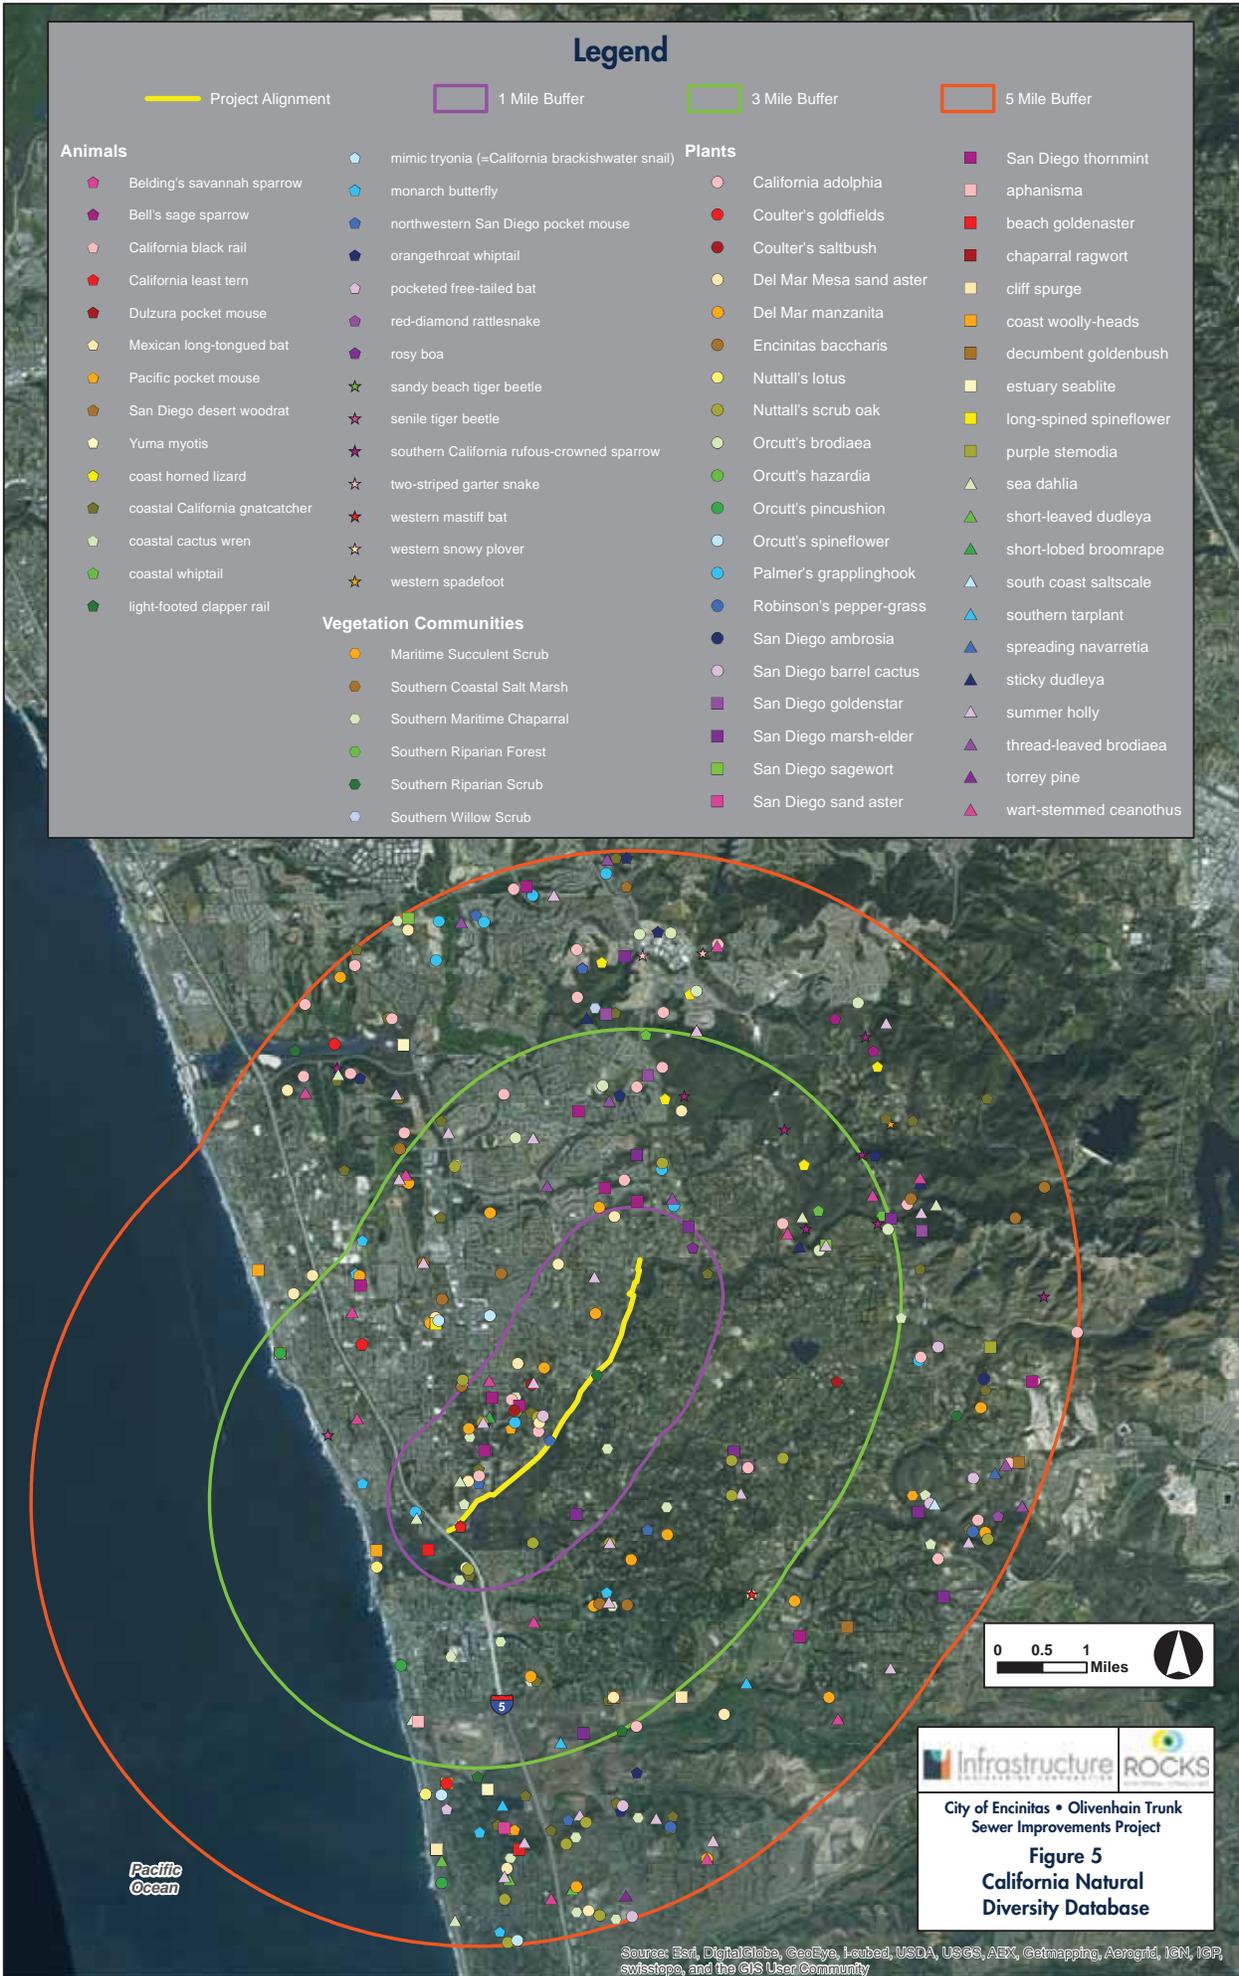
Figure 5

California Natural Diversity Database

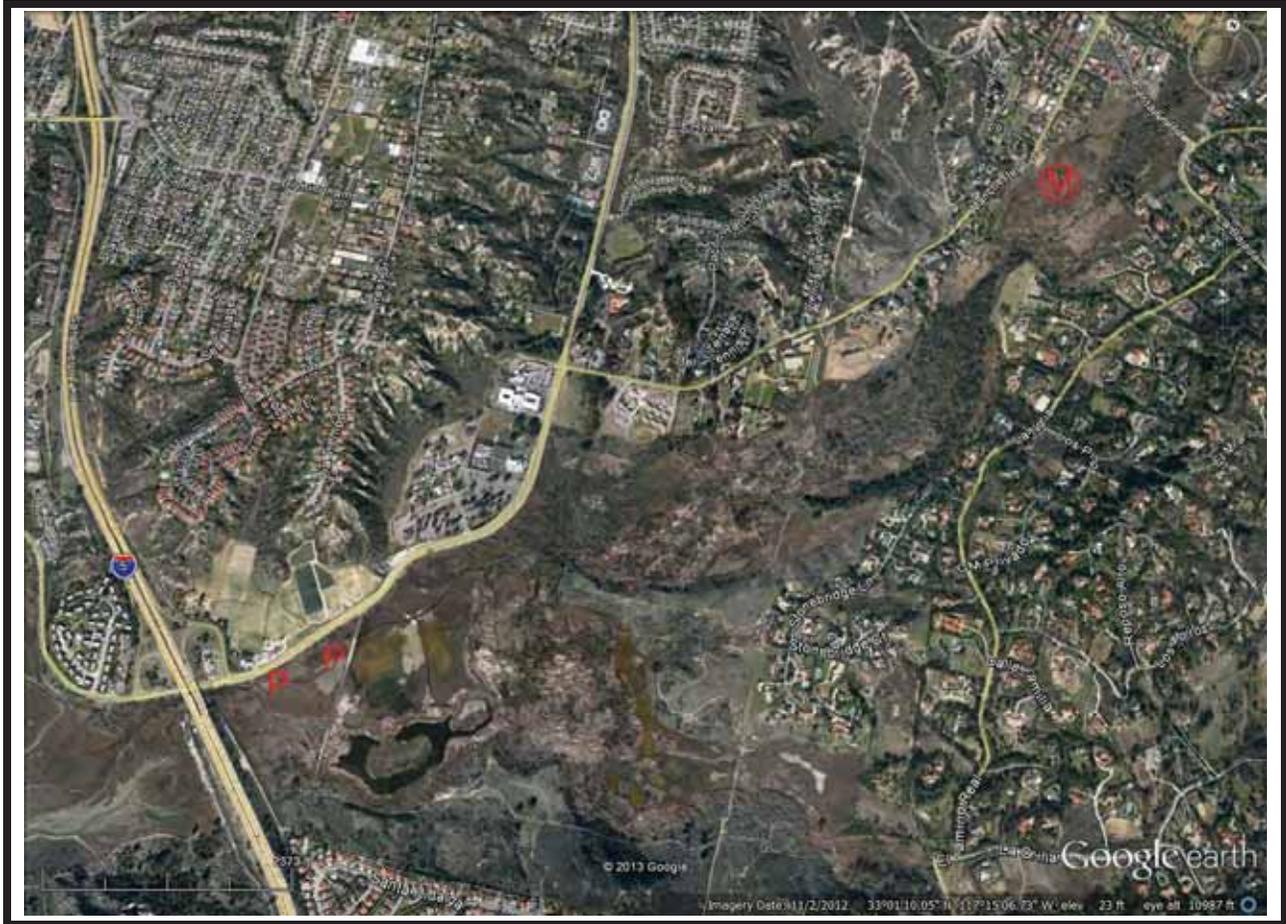
Figure 2. Location of One Single Male and Two Pairs of Light-footed Clapper Rail Detections at the Olivenhain Trunk Sewer Improvement Project Site, San Diego County, 2013. (red P=pair, red M=single male).
